**NASA TECHNICAL  
MEMORANDUM**

**NASA TM X- 73913**

PLASTIC (WIRE-COMBED) GROOVING OF A SLIP-FORMED CONCRETE RUNWAY  
OVERLAY AT PATRICK HENRY AIRPORT---AN INITIAL EVALUATION

Eugene C. Marlin (Peninsula Airport Commission) and  
Walter B. Horne

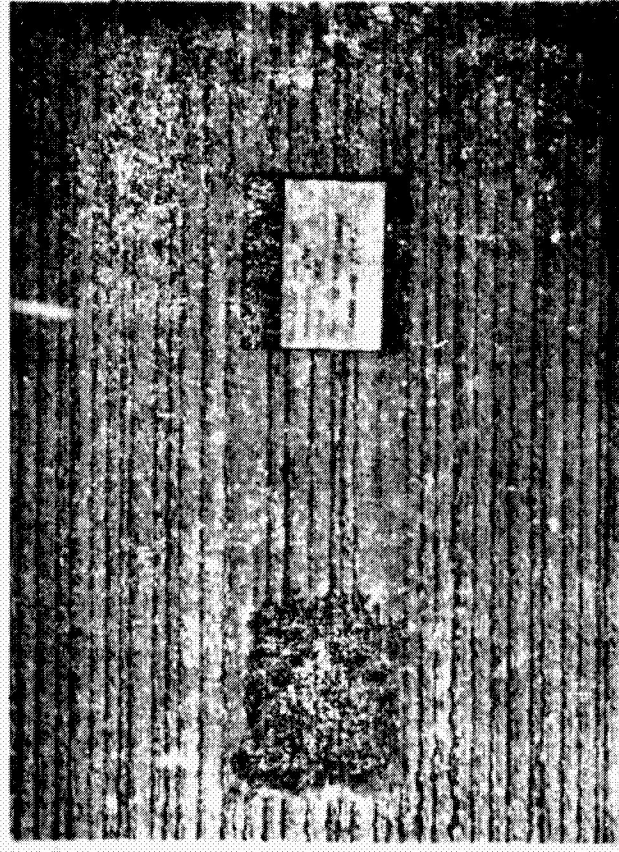
(a) Medium wire combing

(b) Heavy wire combing

Figure 3.- Photographs of typical wire combed surfaces showing results of NASA grease test.  
Runway 6/24, Patrick Henry Airport.

moment to start the wire comb finish treatment to produce a uniform texture on the concrete surface. As a result, the contractor foreman uses his best judgment as to the state of plasticity of the concrete to determine when this finish treatment should start. The variability inherent in such human judgment decisions explains the difference in texture shown for the wire combing examples given in figure 3.

NASA Grease Test.- A measurement of the surface texture depth was made for the two concrete surface finish treatments by means of the NASA grease test which entailed spreading a known volume of grease between parallel tape spaced a known distance apart on the runway surface. The length of the surface between the tapes required for the grease to fill all the asperities, multiplied by the distance between the tapes gives the grease area on the runway. This area divided into the known volume of grease yields the average texture depth of the pavement surface. The results of these measurements are shown in Table II and figures 3 and 5. The data indicate that the average texture depth of the grooved pavement from the wire combing treatment was 2 1/2-3 1/2 times greater than that obtained from the conventional longitudinal burlap drag finishing treatment.

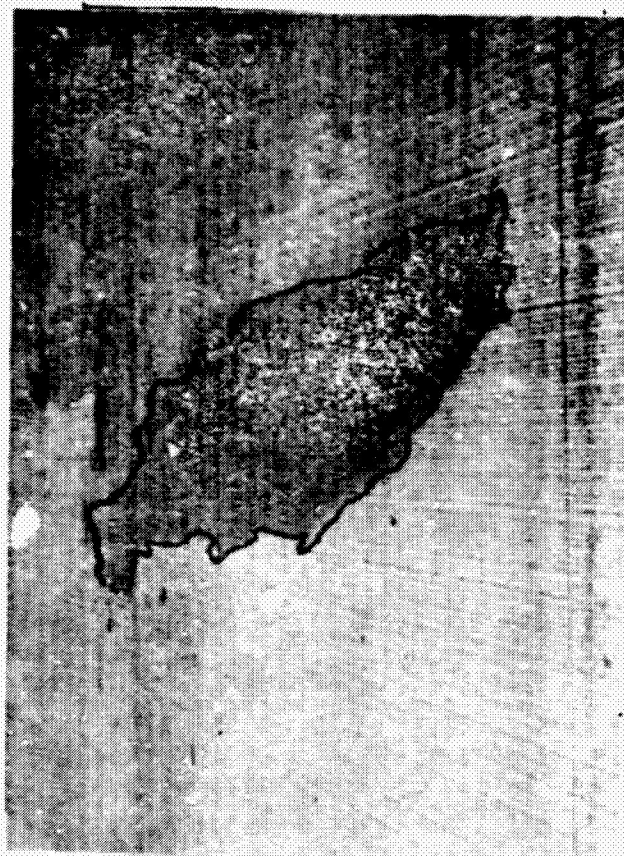
(a) Longitudinal burlap drag concrete finish

(b) Wire-combed (plastic grooved) concrete finish

Figure 6.- Photographs illustrating water drainage on Runway 6/24 at Patrick Henry Airport.  
Wind from 60 degrees at 10 knots.

NASA Dye (water drainage) Test.- After the second water truck pass on each test surface, sodium fluorescein dye to improve water drainage flow visualization was injected into the water-covered test section on the side nearest the runway centerline (top of runway crown). In each case, the cross slope of the runway was 1 percent ( $\frac{1 \text{ ft.}}{100 \text{ ft.}}$ ). At the time of the tests, a 10 knot wind was blowing straight down the runway (wind from 60°). As shown in figure 6, this wind prevented water drainage down the cross slope of the runway having the longitudinal burlap drag surface finish. Instead, the drainage flow path was inclined at a direction nearly parallel with the runway centerline (figure 6(a)). The water drainage was slow and water depths ranging from 0.02-0.04 inch remained in the wetted test section throughout the DBV test period. On the other hand, the NASA dye test indicated water drainage from the plastic grooved (wire-combed) surface of the runway to be much faster than found for the conventional longitudinal burlap drag surface and directed nearly parallel to the transverse runway grooves (nearly straight down the runway cross slope (see figure 6(b))). This rapid water drainage down the pavement grooves resulted in the grooved wetted test

These results suggest that on the conventional concrete surface treatment (longitudinal burlap drag) the draining water is forced to flow on top of the pavement surface where it is exposed to the force of the surface wind. On the other hand, water drainage in the plastic grooved surface is below the top of the surface texture (in the groove channels) and is thus shielded from the force of the surface winds.
